# ADVANCES IN THE USE OF THERMOGRAPHY TO INSPECT COMPOSITE TANKS FOR LIQUID FUEL PROPULSION SYSTEMS

Matthew D. Lansing\*, Samuel S. Russell\*\*, and James L. Walker\*\*

Marshall Space Flight Center

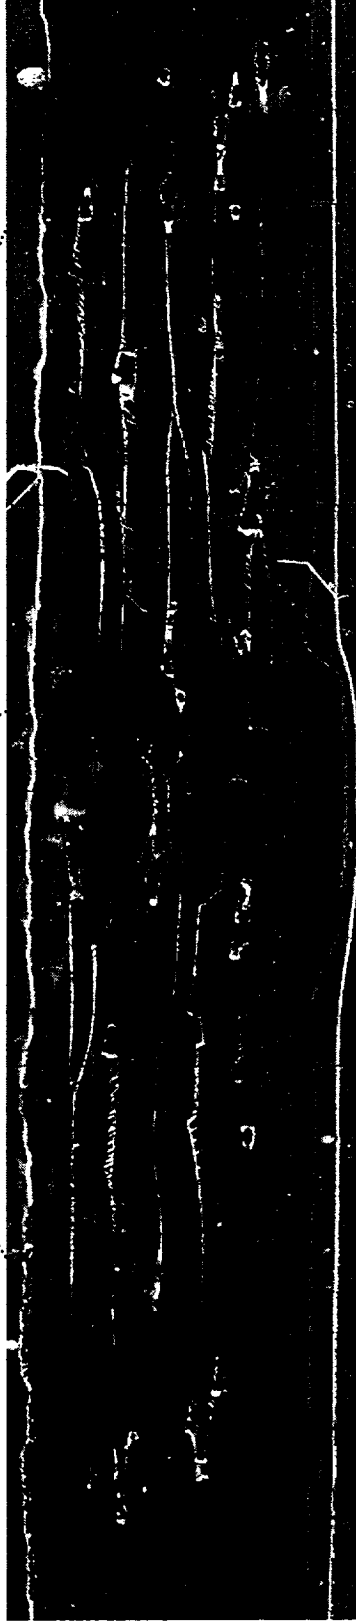
**Photomicrograph (Fluorescent Penetrant)**

**Delaminations at region S5**

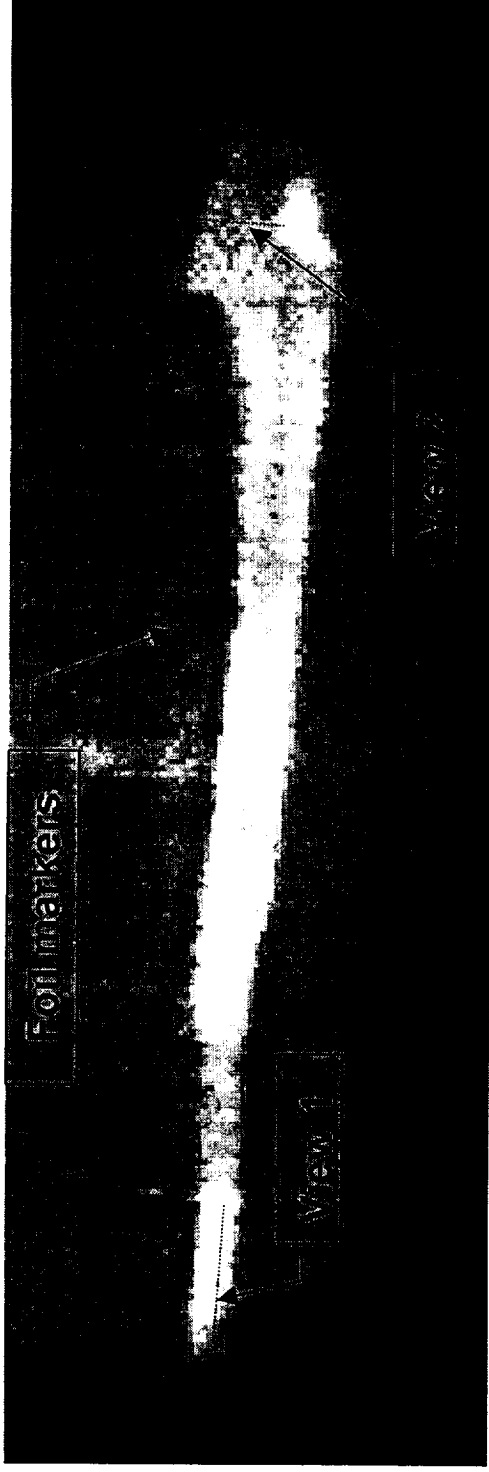
Thermographic indication of inclusion

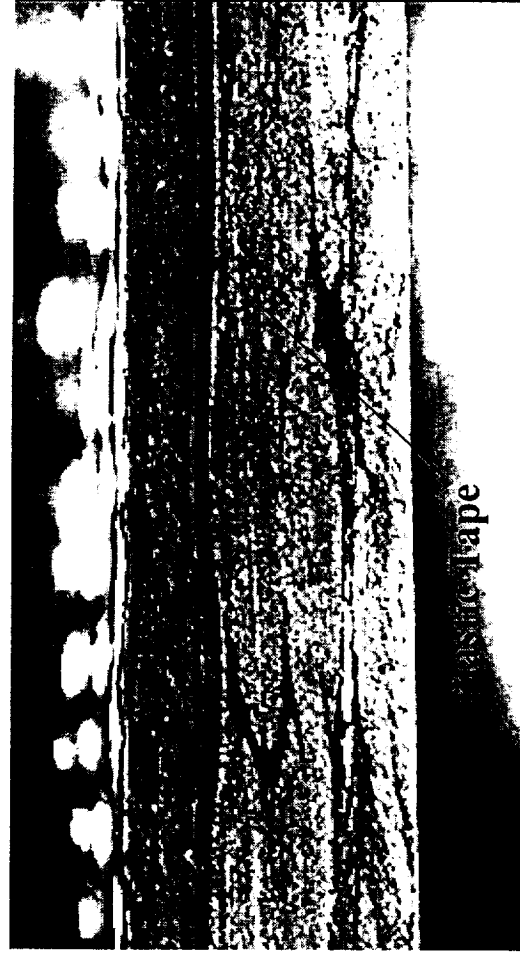
View 1

Photomicrographs of Teflon tape inclusions

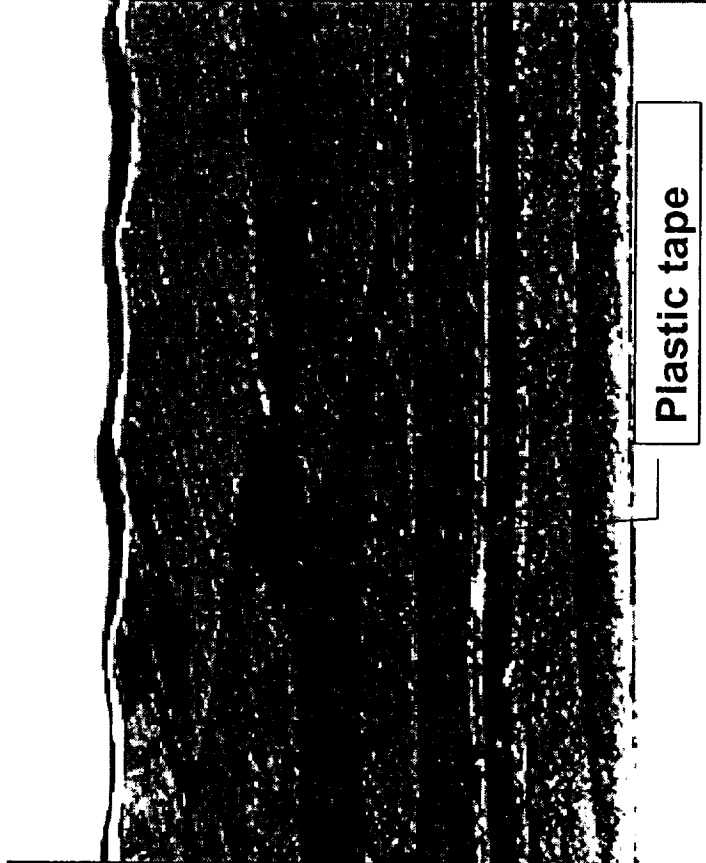
Thermogram	Micrograph

Deeply embedded plastic tape inclusions

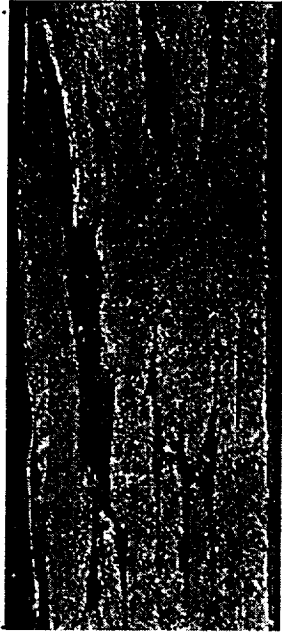
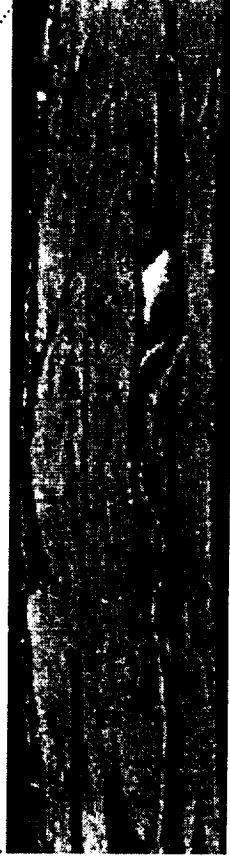
**Defect at position A4**

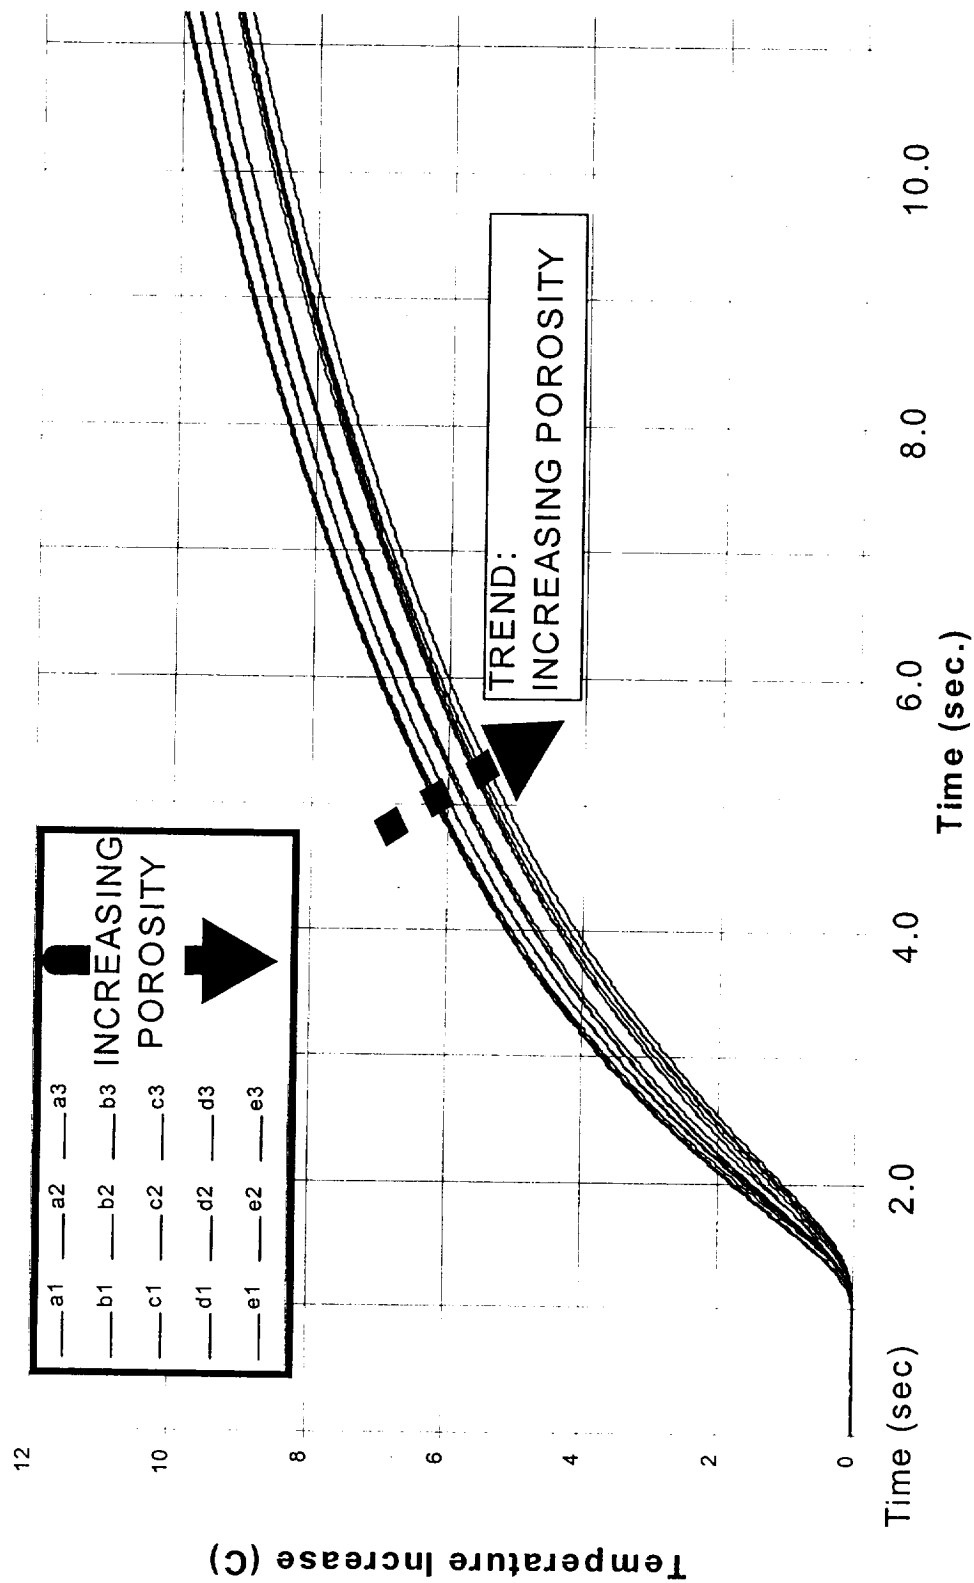
# POROSITY IN GRAPHITE EPOXY
